# Floodplains Reimagined: Juvenile Salmon Rearing Habitat Restoration Opportunities Within the Sacramento River Corridor

**River Partners Technical Assistance**

Noelle Patterson and Chris Campbell August 11, 2023

Floodplains Reimagined Advisory Committee Meeting August 11, 2023 Virtual

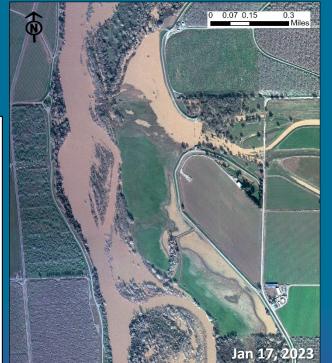
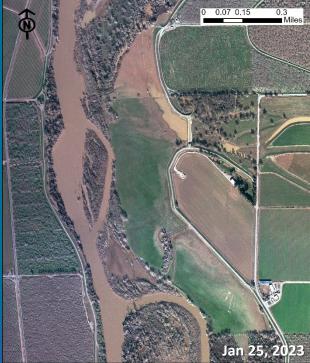
- Flyover images taken between Hamilton City and Colusa
  - ~30 photos per day with 60% overlap
- Four dates during a flood recession, January 17-25, 2023
- Images combined and orthorectified for spatial analysis

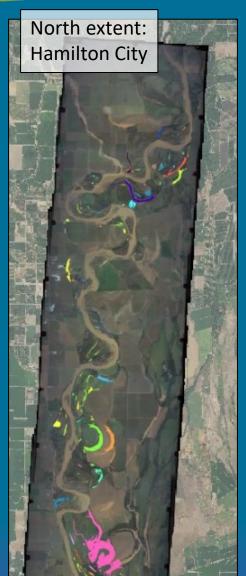
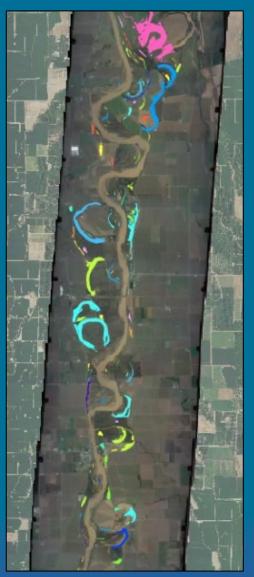
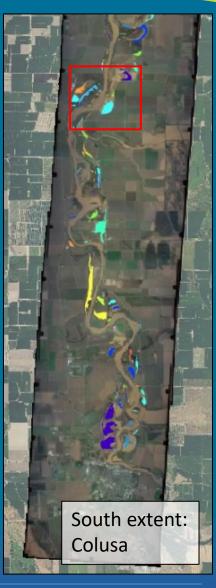
- Pools identified as disconnected areas of inundation
- Grouped by deactivation flow (between 10,000 75,000cfs, 5,000cfs intervals)
- Quantified by:
  - Surface area (acres)
  - Volume (acre-ft)
  - Proximity to the main channel (ft)
  - Limiting infiltration rate (in/hr)

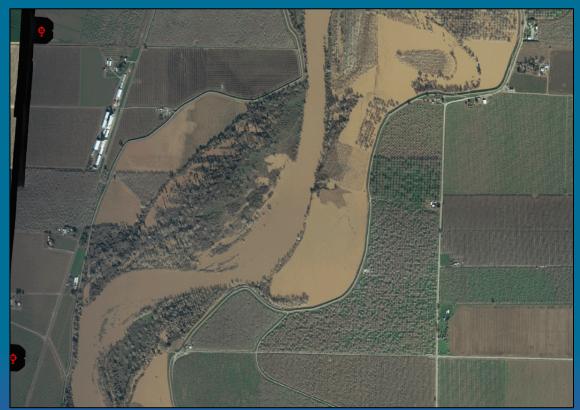
# **Willow Bend**

Colored areas, no outline = modeled channel inundation

Outlined colored areas = identified standing pool locations

Large ponds disconnect from the main channel at 35,000 and 15,000 cfs

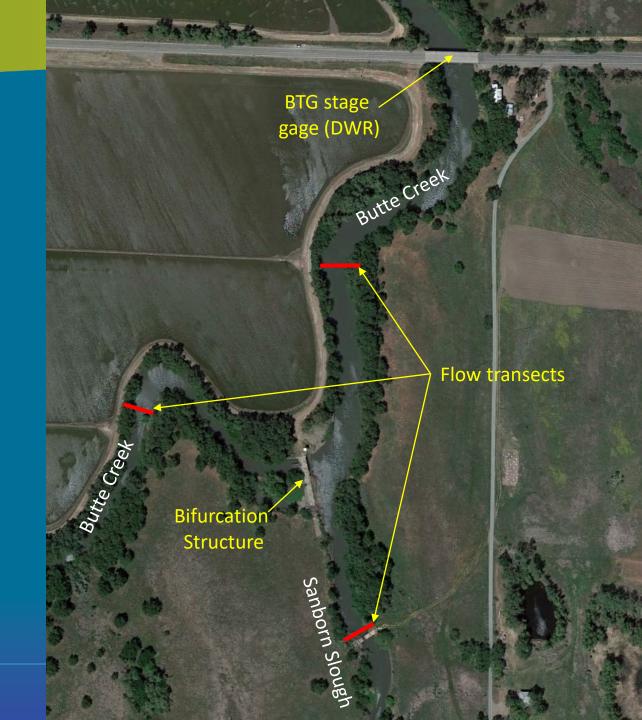
#### **Flow Measurements**

- ➤ RDI River Pro ADCP with RTK-GPS
- Pressure transducers on Sanborn Slough and Butte Creek downstream from the Bifurcation Structure (BTG gage upstream on Butte Creek); recording depth every 15 minutes
- ➤ Water-surface elevation measurements with RTK-GPS to convert to NAVD88
- ➤ 6 sets of measurements (all 3 transects) from November 2022 through February 2023
